K-PLUS ENGINEERING

LIMITED PHASE II ESA - SUBSURFACE INVESTIGATION

Residential Building & Auto Repair Garage
568-576 E. 115th Street
Chicago, Illinois 60628
Cook County

April 20, 2011

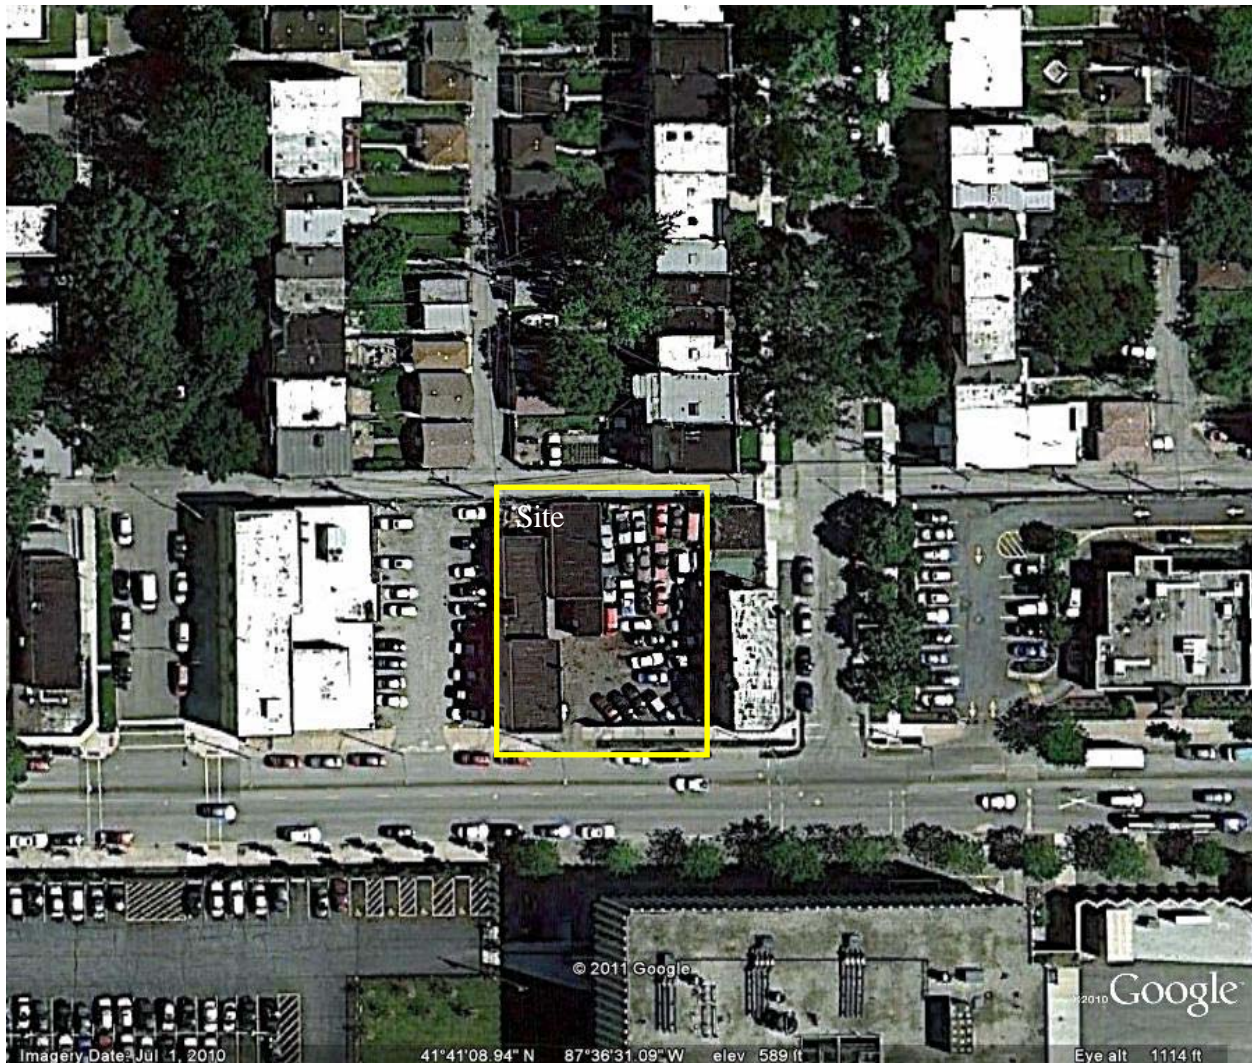
Figure 2 – Site and Surrounding Area (Aerial 2010)

The Subject Property is located in a mixed use area. Specifically, the Subject Property is bounded on the **north** by a public alley, followed by a residential subdivision; on the **east** by residential building, followed by S. St Lawrence Avenue and then by a restaurant property; on the **west** by a parking lot and then by a commercial building; and on the **south** by E. 115th Street followed by a large industrial facility operated by Sherwin-Williams (Figure 2).

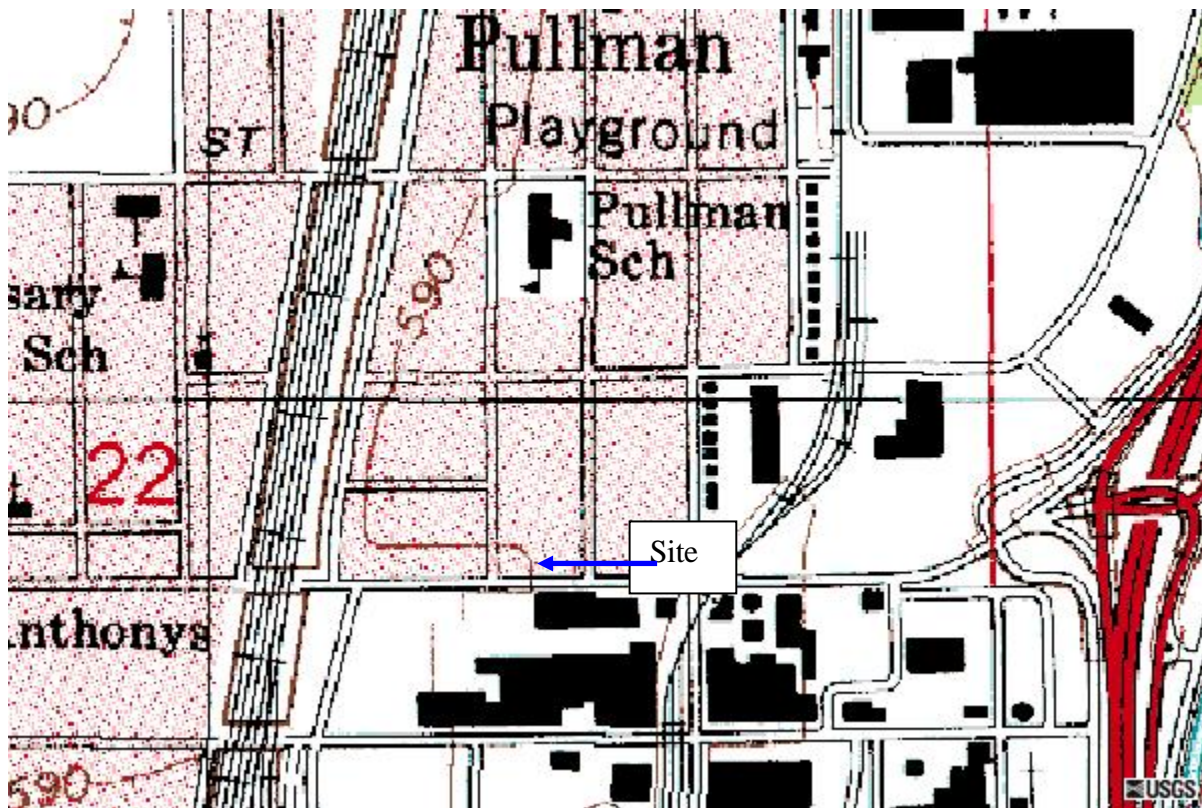
Figure 3 – Topographic Map

In general, the topography of the Subject Property is relatively flat, with no discernible elevation changes. According to the United States Geological Survey 7.5 Minute Series Topographic Map of Lake Calumet, Illinois Quadrangle (1997), the Subject Property lies at a relative surface elevation of approximately 590 feet above mean sea level. Surficial and near surface groundwater is expected to flow in an easterly direction, towards Lake Calumet, which is located approximately ½ mile to the east of the Subject Property. Regional groundwater flow in the area, is also expected to flow in an easterly direction, towards Lake Michigan, which is the nearest significant surface body of water (Figure 3).

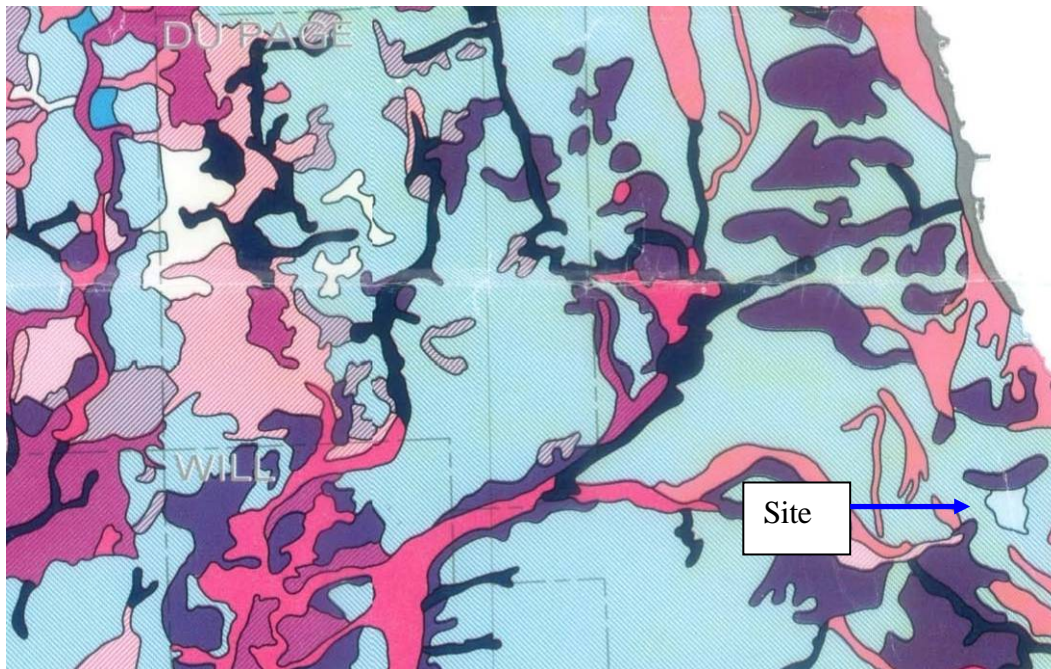
Figure 5 – Berg Map

According to the Berg Map, the regional geologic materials in the area are designated as type as an “E”-type soil (Figure 4). An “E” classification is described as uniform, relatively impermeable silty and clayey diamictons greater than 50 feet in thickness, with no evidence of interbedded sand and gravel.

Field observations of borings advanced at the Subject Property during this investigation revealed shallow fill followed by clay to a depth of approximately 12 feet below grade level. The field observations were consistent with geological map findings.

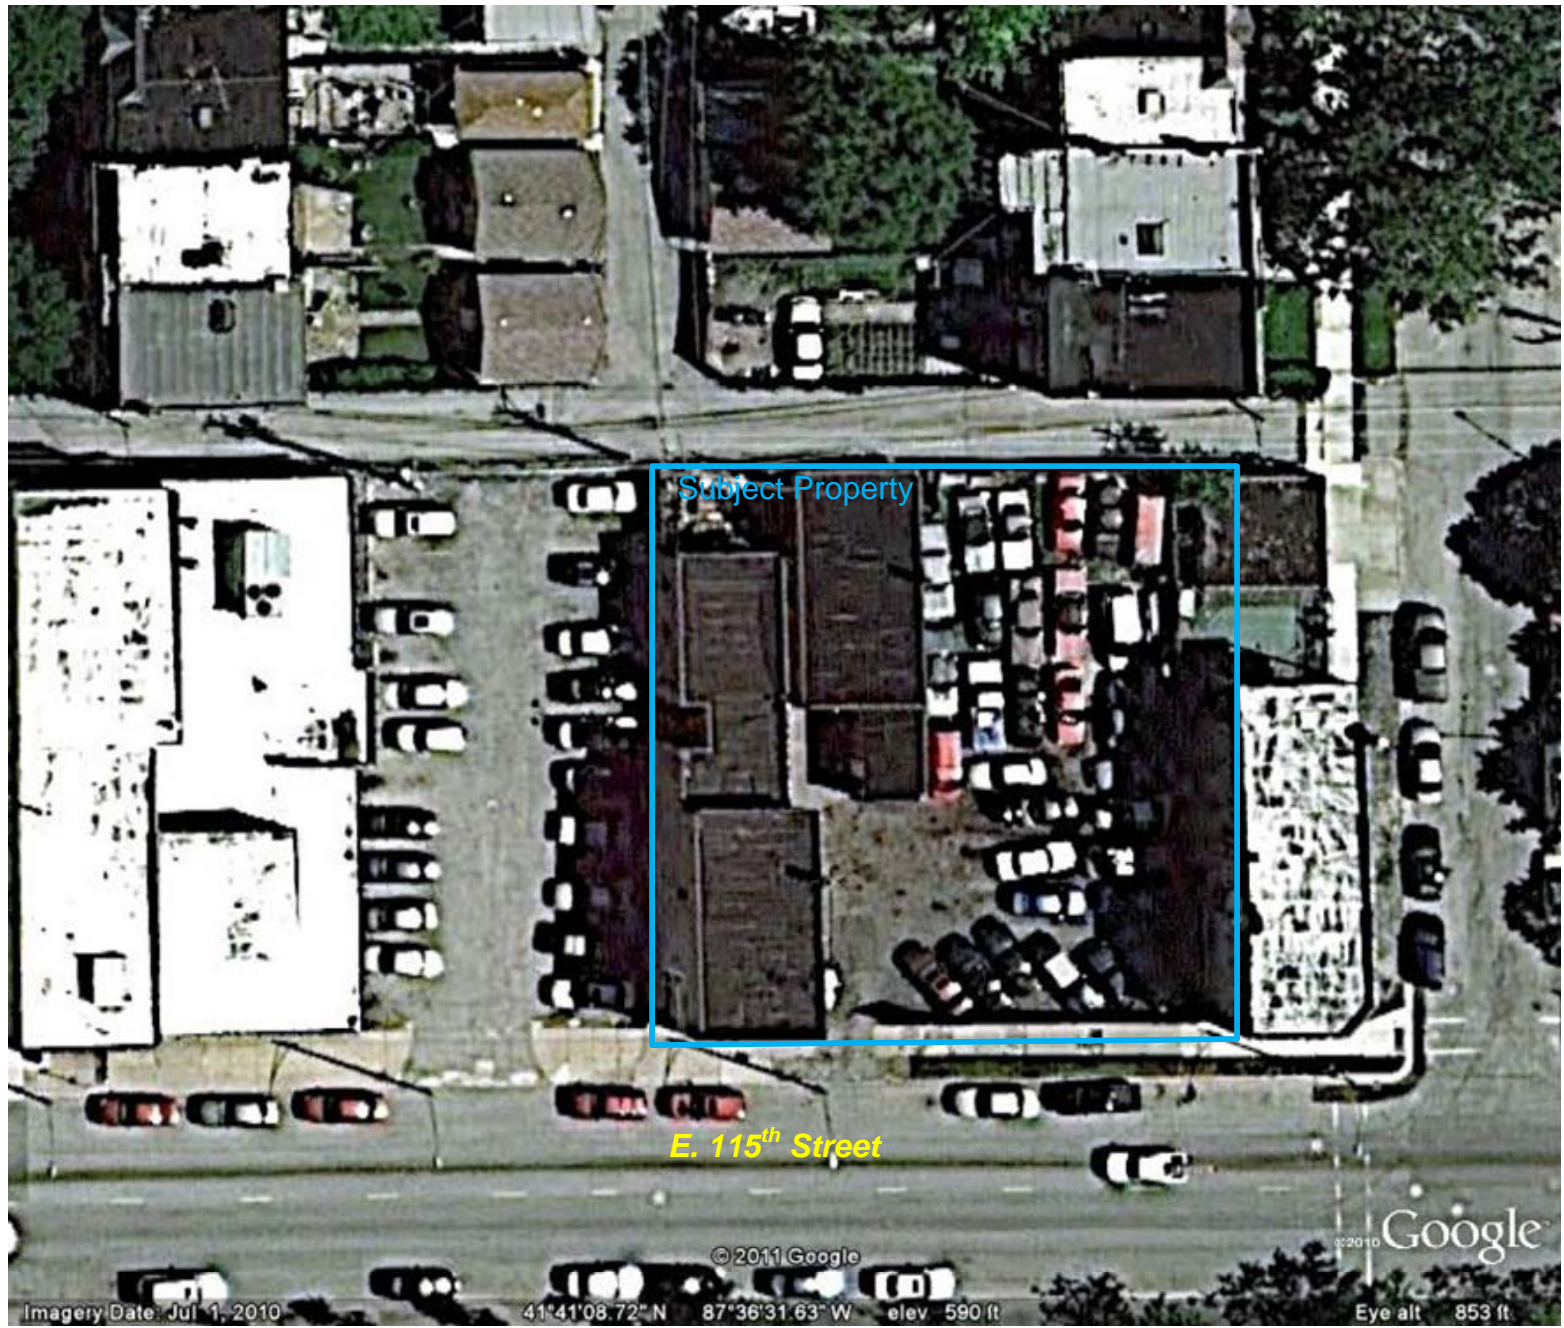
Site Map
568-570 E. 115th Street
Chicago, Illinois

In order to evaluate the subsurface soils, a total of seven (7) soil borings were advanced to a depth of 12 feet bgs at selected areas of the Subject Property. Soil borings (B01 through B07) were performed to determine if the operations at the property, both current and historic, had negative impacts to the subsurface.
